# **SHIP CRASH INTO THE RIVER DANUBE RAILWAY BRIDGE IN KREMS – MONITORING AND ALARMING SYSTEM FOR THE DAMAGED STRUCTURE**

Peter Furtner  
VCE, Austria

Helmut Wenzel  
VCE, Austria

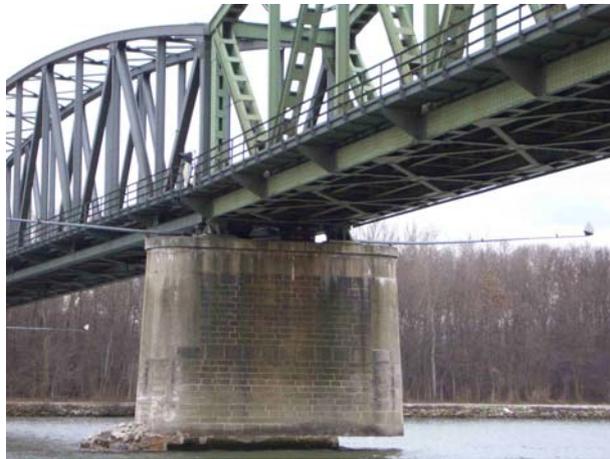
In the early morning of 17 December 2005 a ship loaded with more than 3500 tons iron ore traveling upstream the Danube River crashed into the center pier of the railway-bridge in Krems - Austria. The pier was sheared off above the water surface and moved 2.17 meters upstream (Figure 1).

The submerged part of the pier stub was checked by divers. They noticed numerous cracks at the pier stub. Due to the check results failure mechanisms were

Figure 1: Damaged pier

The great mass of the superstructures influenced the dynamic behaviour of both piers. For both piers the same eigenfrequencies were identified in cross direction (normal to the flowing direction). This can be attributed to a reciprocal transmission of the vibration behaviour of the piers by the superstructures. This behaviour indicates that the damaged pier was held in its position by the supported superstructures because of constraining forces introduced by the displacement and distortion of the structures during the ship crash. The test also assessed the monolithic behaviour of the displaced pier shaft. From the measuring results no signs of an imminent brittle fracture can be seen.

The monolithic behaviour of the displaced pier shaft was assessed by the check. From the measurement results no signs for any brittle fracture could be recognized.

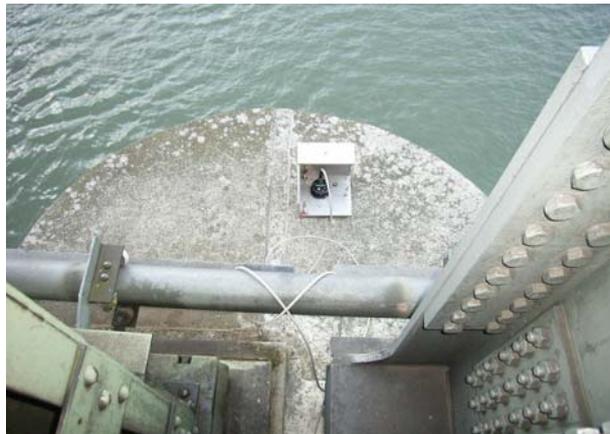
- Damaged pier, upstream (Figure 2).
- Damaged pier, downstream.
- At both superstructures supported by pier 5 at a distance of approx. 20 m of the pier.

Figure 2: Sensor on the damaged pier

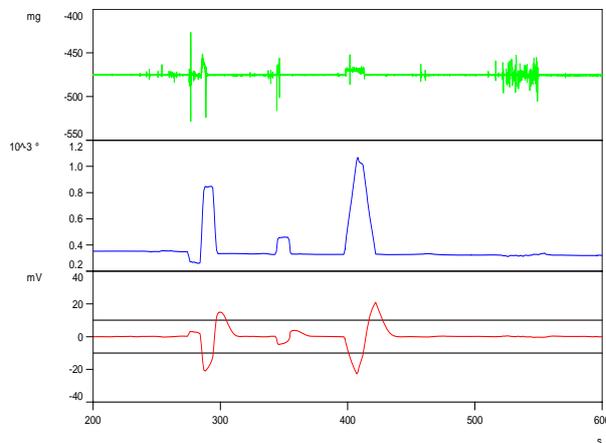
Figure 3: Test of the monitoring system

After installation the proper function of the system was tested by manual inclination of the sensors. Figure 3 shows the results of this test:

- The raw signal
- The inclination
- The trigger criterion with the threshold values

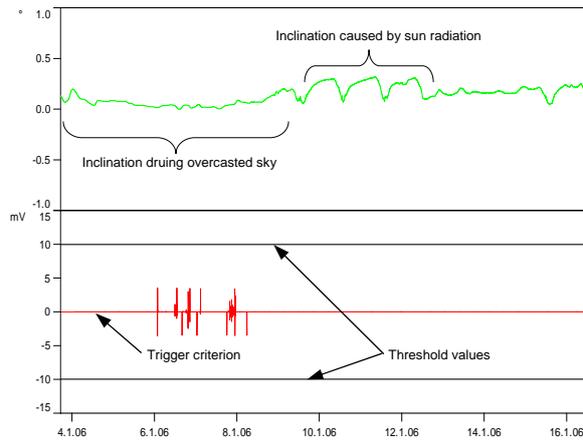
All recorded measuring data were saved on site and subsequently evaluated and graphically processed. Figure 4 shows typical results of permanent monitoring. The influence of insolation on temperature expansion and the pier inclination influenced by it can be clearly recognized.

Figure 4: Typical monitoring results from the damaged pier

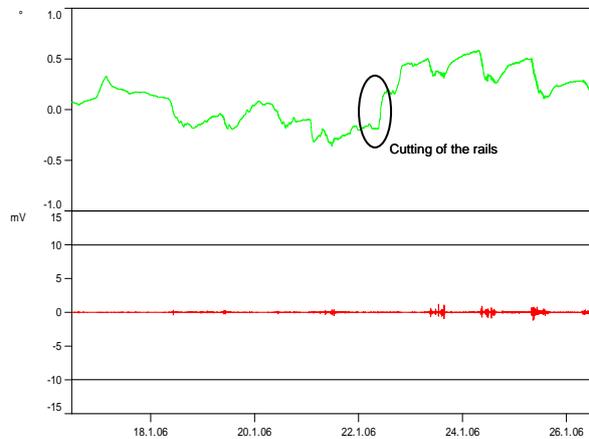
In Figure 5 the slight movement caused by the loosening of the rail fastenings and the cutting of the rails can be seen.

On 31 January a sensor was knocked over during the cutting of the cable trough. This led to an exceeding of all threshold values. The slight change in position of the sensor during the resetting was expressed by a displacement in the measurement record.

Figure 5: Inclination during cutting of the rails
