Traun Bridge W4 Steyrermühl

The bridge object is part of the A1 highway and was constructed in 1959. It is composed of 10-spans (reinforced concrete) and has a total length of 240.45 m. A comprehensive dynamic analysis on the present bridge object was conducted by means of BRIMOS[®] Structural Health Monitoring.

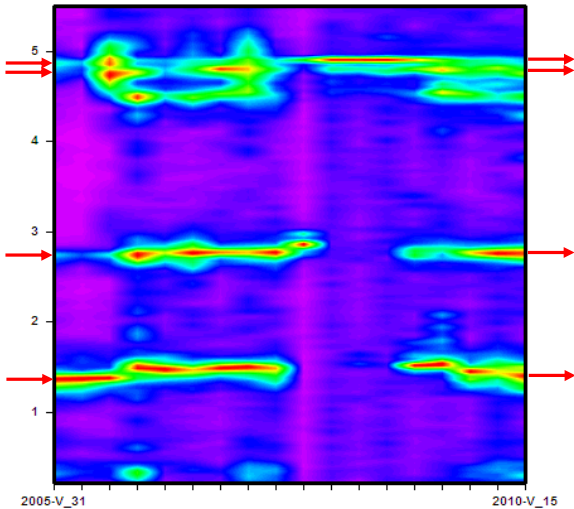
Progression of **measured structural stiffness patterns 2005-2010** (0.2-5.5 Hz) including exposure to bridge blasting and response to heavy freight traffic before and after this exceptional loading case – driving direction Vienna

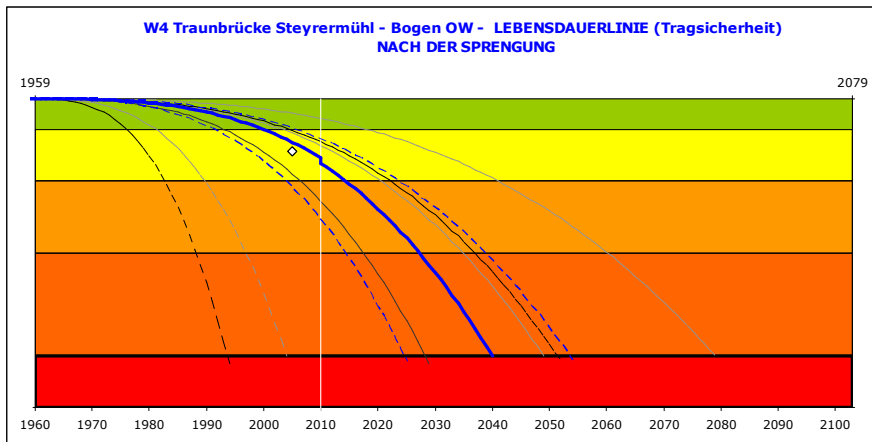
Measurements at selected single bridge locations (HOT SPOTS) enabled a comprehensive documentation and quantification of the bridge's decisive structural behaviour and possible changes respectively. A direct comparison after 5 years of structural service life shows the progression of the calculated life cycle curve (bridge deck under the influence of traffic load and the bridge blasting) from 1959.

Life - Cycle Analysis including the influence of the exceptional loading case of bridge blasting
