Eko Bridge (Main Bridge East) in Ijora, Lagos

- Client: BBV Systems
- Location: Lagos, Nigeria
- Checking Period: 2010
- Services: Dynamic measurement
BRIMOS Assessment and rating

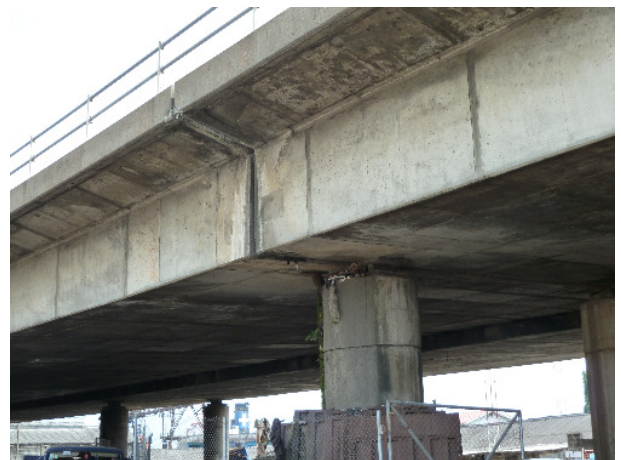
The Eko Bridge is located in Ijora, Lagos and connects Lagos Mainland with Lagos Island. The prestressed structure consists of two separate load-bearing structures – one for each driving direction. The Main Bridge East which was part of the BRIMOS® investigation has a total length of 190 m and was opened to traffic in the early 1970ies. The cross-section of the superstructures comprises of a three cellular box girder and has a width of 14m.
