# Addressing ground-shaking-induced damage of the gas distribution network in the 2009 L`Aquila earthquake

*Keywords: lifelines, pipelines, repair ratio, resilience.*

## ABSTRACT

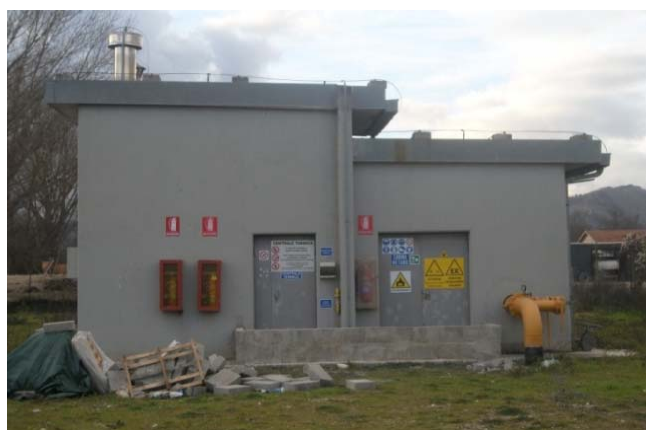
The three M/R stations (Re.Mi. stations) of the L'Aquila distribution system are cased in one-story reinforced concrete structures with steel roofs (Figure 2) hosting internal regulators and mechanical equipment (heat exchangers, boilers and bowls) where the gas undergoes the following processes: (1) gas preheating; (2) gas-pressure reduction and regulation; (3) gas odorizing; (5) gas-pressure measurement.

Figure 2. M/R Metering/Pressure reduction station in Onna (L'Aquila, Italy)

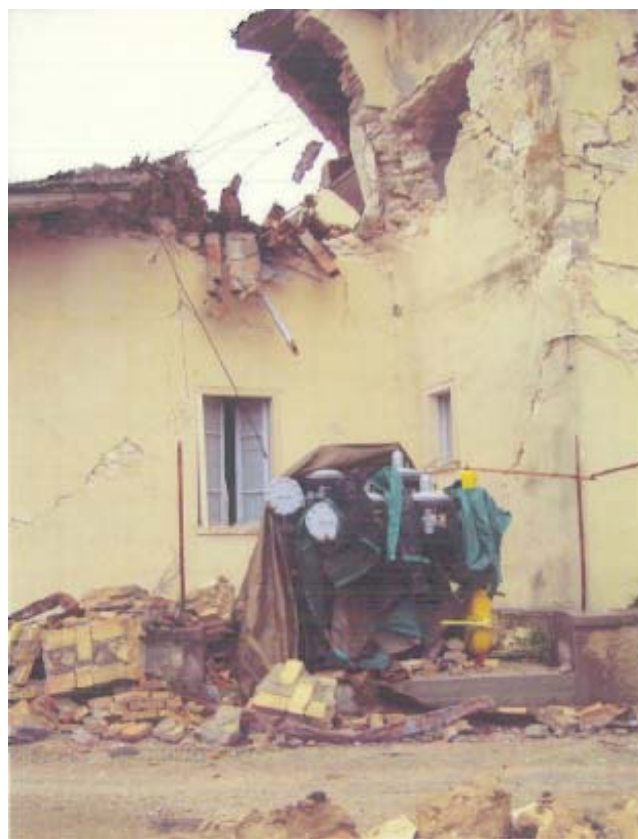
The 300 Reduction Groups, that in the L'Aquila gas distribution allow for the transformation of the medium distribution pressure into the low distribution pressure are either buried, sheltered in a metallic kiosk or housed within/close to a building (Figure 3).

Figure 3. GR housed in a masonry kiosk closed to building and damaged following the 6<sup>th</sup> April 2009 earthquake.

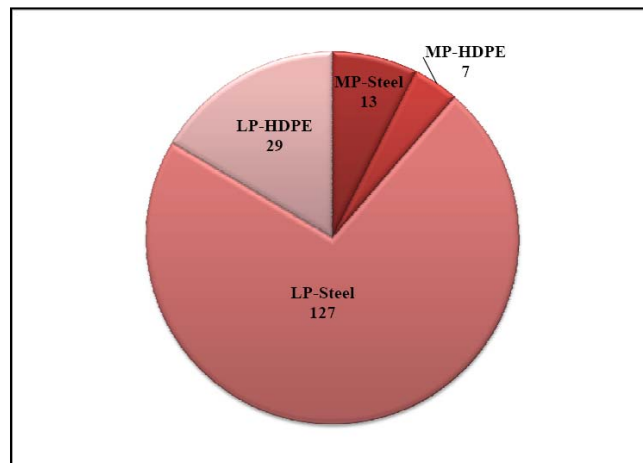
Figure 7 illustrates this operations included in the dataset distinguished in relation to pressure level and pipe material.

Figure 7. Dataset distinguished in relation to pressure level and pipe material.
