Giuliana Bridge

Description

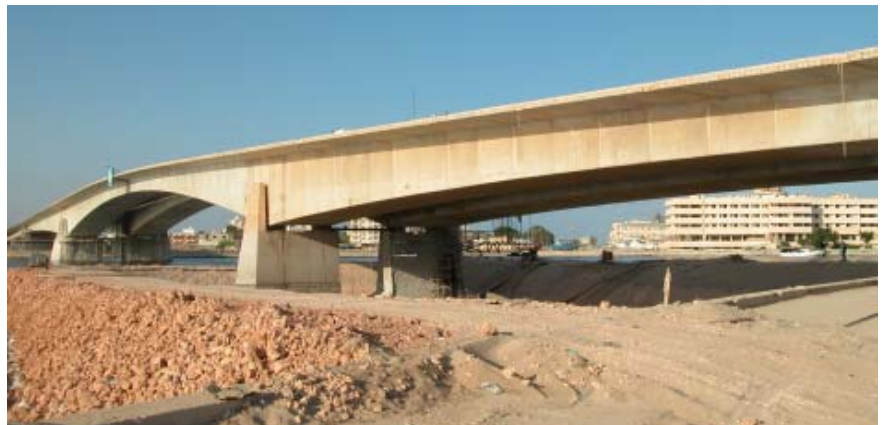
The Giuliana bridge in Benghazi / Libya consists of 4 single-span foreshore bridges per lane and a three-span main structure. The foreshore bridges have a total span of 35 metres. The cross-section has the form of a double box girder with continuous deck, prestressed in longitudinal direction in the footbridges and floor slabs.

The two main structures with spans of 80-120-80 metres are haunched box girders. The main structures are prestressed in longitudinal and cross direction (deck pavement). The object was erected in the 1970s.

The structure was generally rehabilitated by Bilfinger Berger. In the course of the works great corrosion was detected at the longitudinal and cross tendons. First investigations have shown defective pressure grouting of the tendons.

The global maintenance state of the structure was analysed by the dynamic investigations with BRIMOS® . In addition statements on the condition of prestressing and recommendations for the further procedure during rehabilitation were made.
